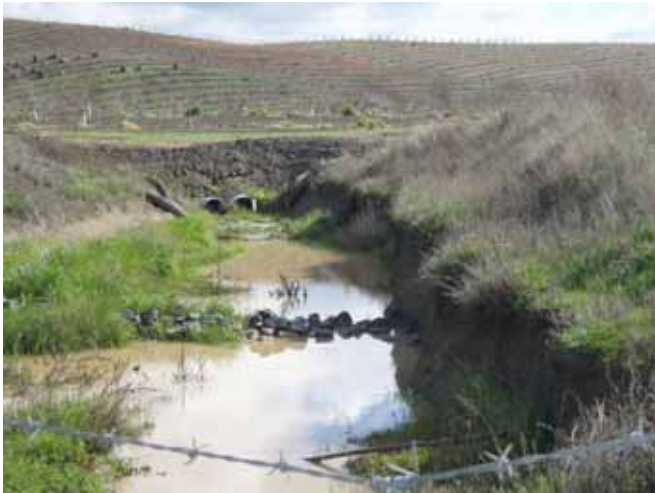
Figure 1: Taken 26 January 2009. Site of Sample # 3. Flow continues, but less than on 25 January.

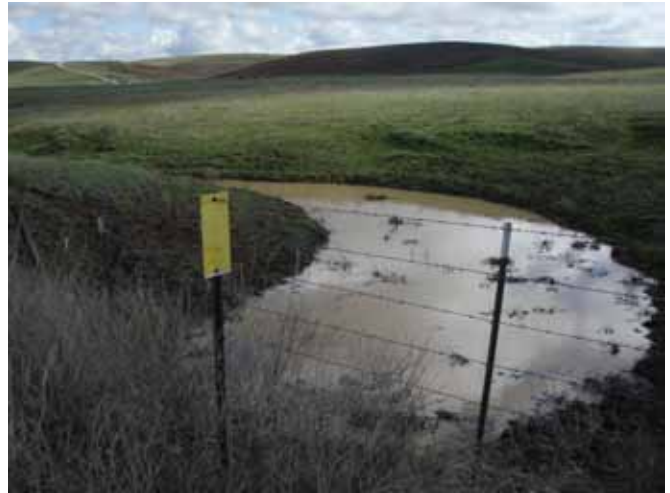
Figure 2: looking south from Lake Road toward the Stanislaus Almond Ranch property.

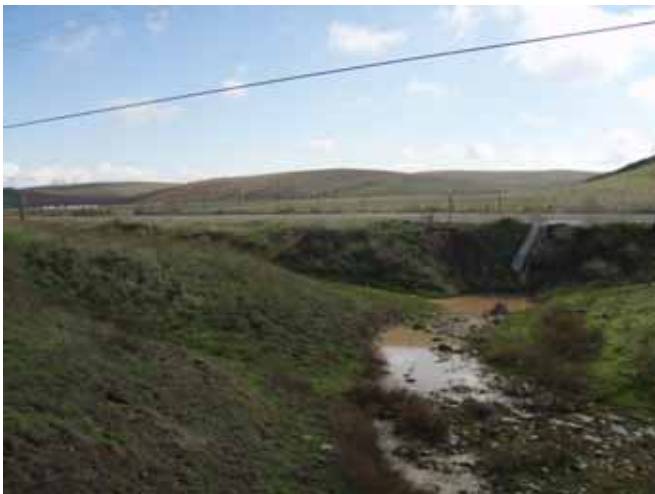
Figure 3: Looking south from north of Lake Road toward the location where the discharge left the property. Not yet at the confluence with Peaslee Creek. Turbidity = 781 on 26 January. Turbidity = 1200 NTU approximately 50 yards further down-gradient during the 25 January DF&G investigation.

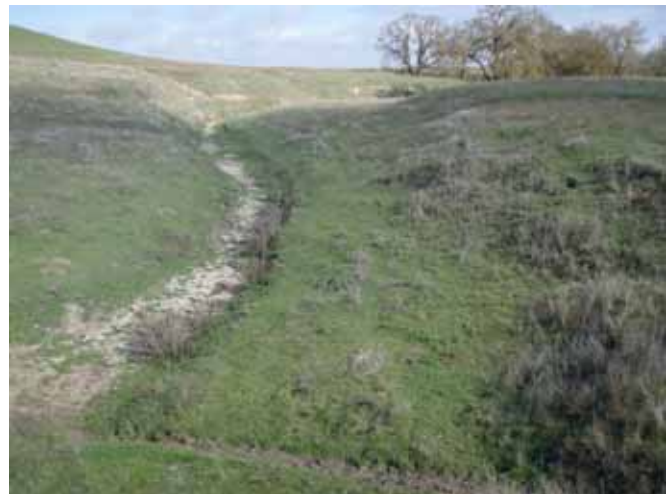
Figure 4: Looking at Peaslee Creek up-gradient from the confluence with the area drainage discharge. Peaslee Creek was dry during 25 January and 26 January inspections.

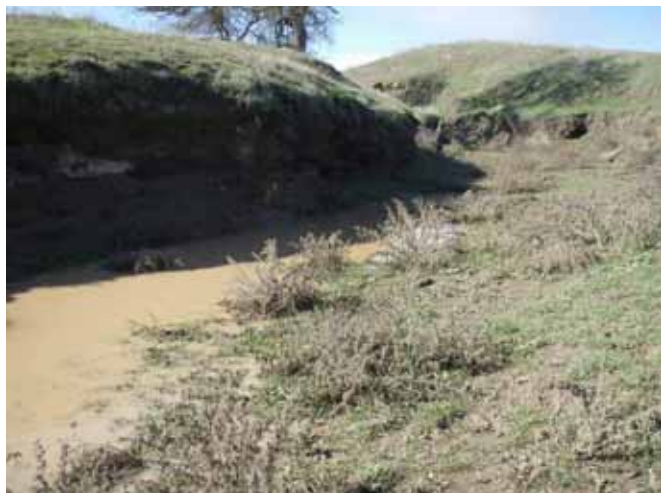
Figure 5: Looking down-gradient at Peaslee Creek after the area drainage with the sediment discharge flowed into it.

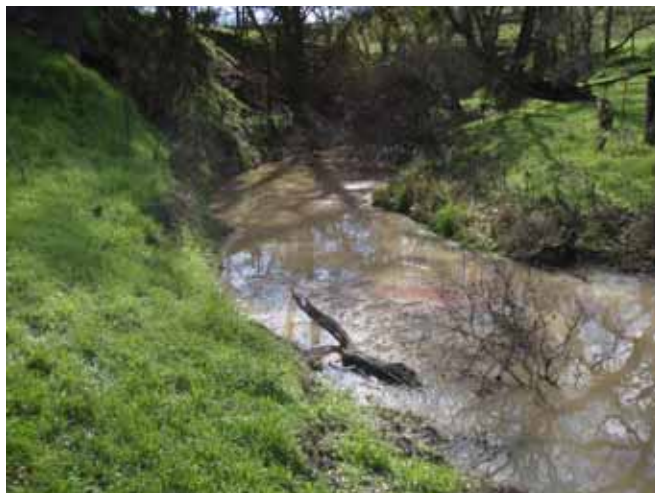
Figure 6: Looking up-gradient at Peaslee Creek where it flows into the Tuolumne River. During the 25 January DF&G sampling the Turbidity = 2000 NTU. The Turbidity = >1000 on 26 January.

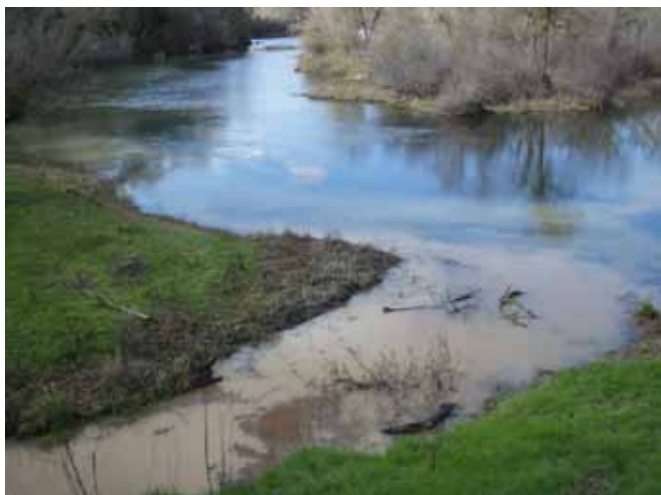
Figure 7: Peaslee Creek confluence with Tuolumne River; Turbidity was measured at 2 NTU on 25 January and 4 NTU on 26 January upstream of the confluence in the Tuolumne River.

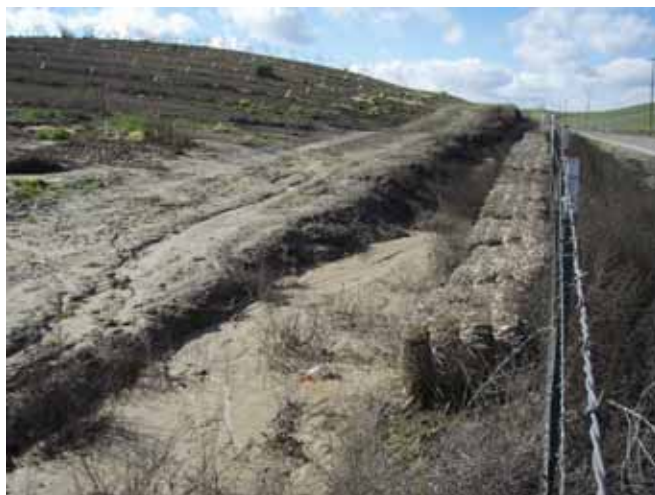
Figure 8: Looking south along Lake Road at the Lake Road Grizzly Ranch property. No flow was observed during the 26 January 2009 inspection.

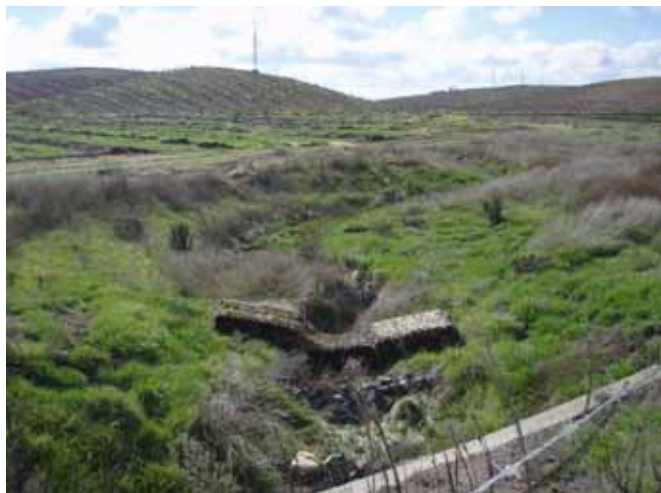
Figure 9: Looking at the Lake Road Grizzly Ranch property watershed from Lake Road. No flow was observed during the 26 January inspection.

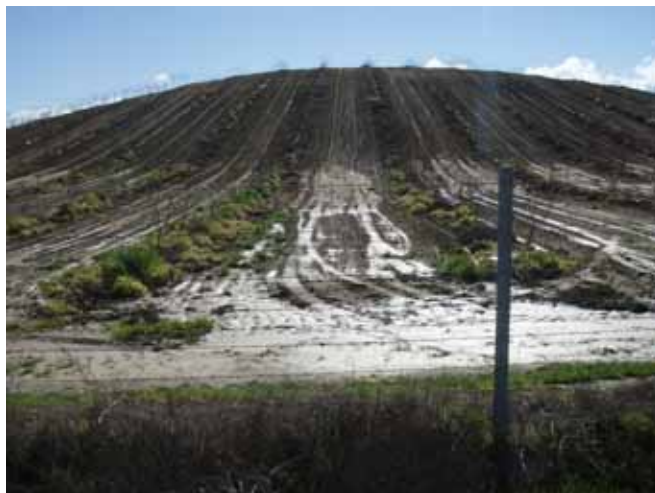
Figure 10: Looking south from Lake Road showing sediment and erosion from the orchard cropland.

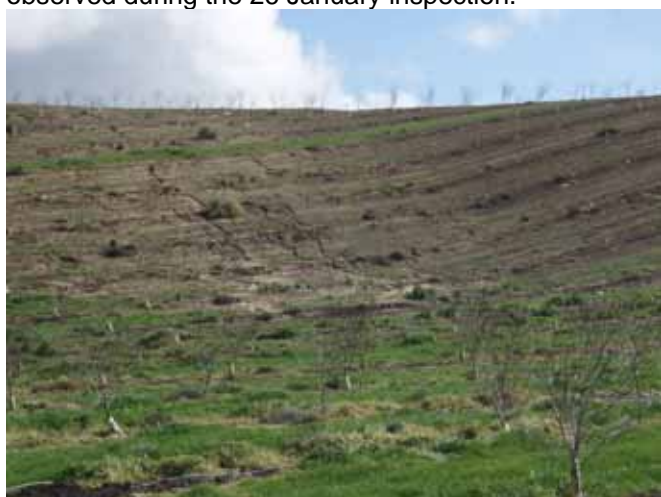
Figure 11: Looking south from Lake Road showing sediment and erosion from the orchard cropland.
